NYSERDA CHP Assessment Report
ASSESSING THE CHP PLANT AT SEA PARK WEST

October 9, 2013

Sea Park West

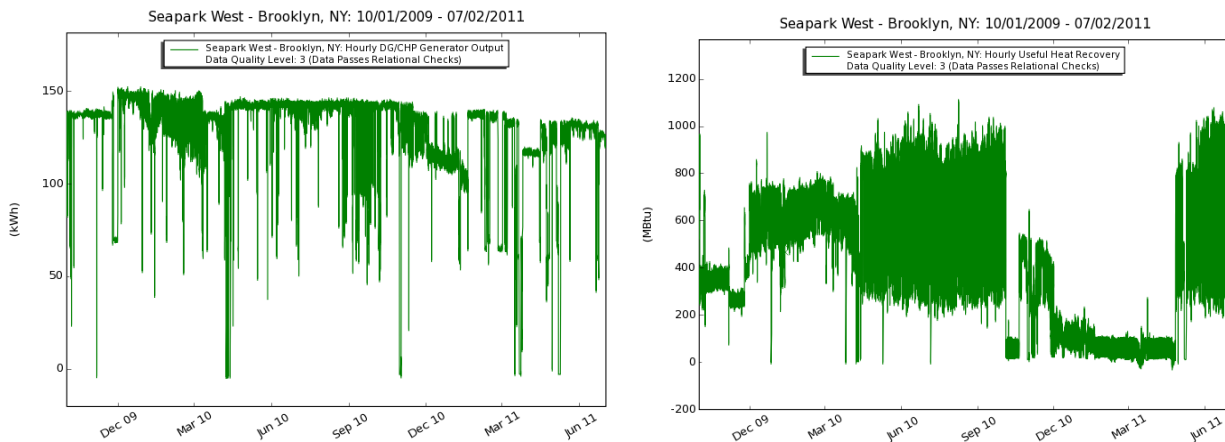
FIGURE 1 NYSERDA CHP WEBSITE PERFORMANCE GRAPHS

NYSERDA's web-based DG/CHP data system provides general equipment information and detailed performance data, however, data alone does not provide the complete picture with respect to CHP systems design or performance. This report seeks to explain the performance data presented in the two fundamental output graphs: kW/h versus time and Useful MBtu/h versus time.

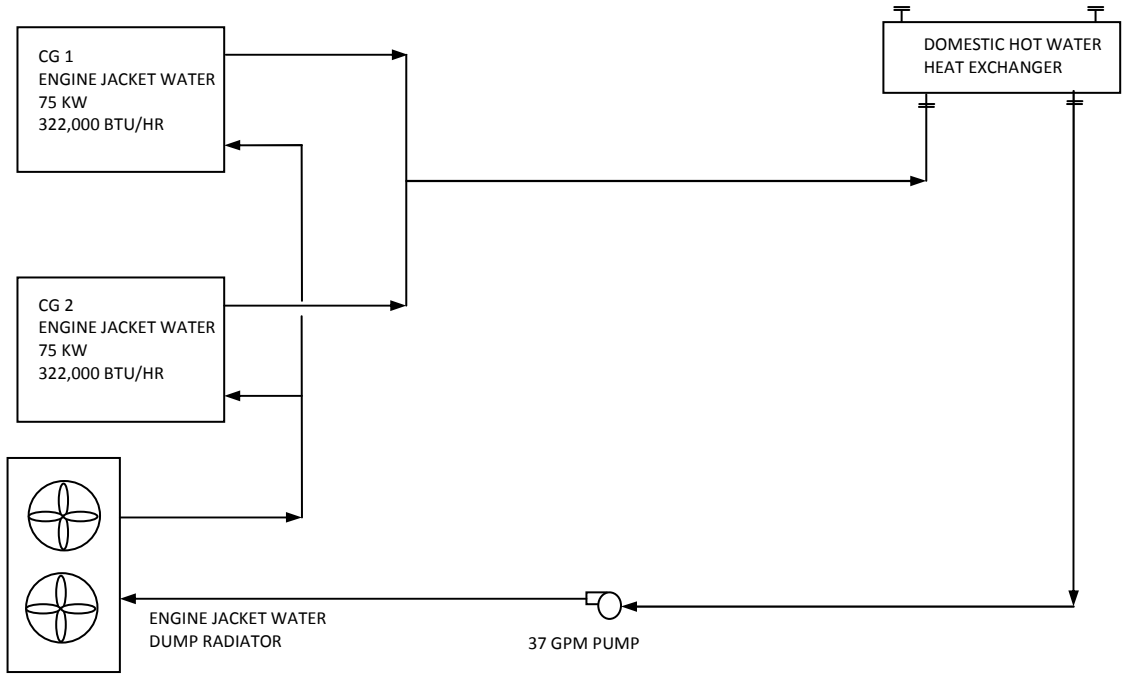
FIGURE 3 SIMPLIFIED SCHEMATIC OF LOW TEMPERATURE HEAT RECOVERY SYSTEM (JACKET WATER / DOMESTIC HOT WATER)

The CHP system at Sea Park West includes two Tecogen 75 kW engine generator units. The two units combined provide 150 kW gross electrical output. The thermal energy output from the units is used for the domestic water heating and space heating loads. The low temperature heat recovery loop includes a DHW heat exchanger (HX) and a dump radiator to reject unneeded heat (Figure 3). Each Tecogen unit also includes an exhaust-to-hot water HX that adds heat directly to the boiler drum (Figure 4). In the summertime, the jacket water and exhaust HXs are plumbed in series so that both their outputs are directed towards the DHW load.

1. A “2-pipe arrangement” where the jacket water and exhaust heat exchanger are in series and serve the domestic hot water heat exchanger (DHW HX) (Figure 3 plus exhaust heat recovery in series with jacket water system).
2. A “4-pipe arrangement” where the exhaust heat recovery HX is piped directly to the boil drum. (Figure 3 plus Figure 4)

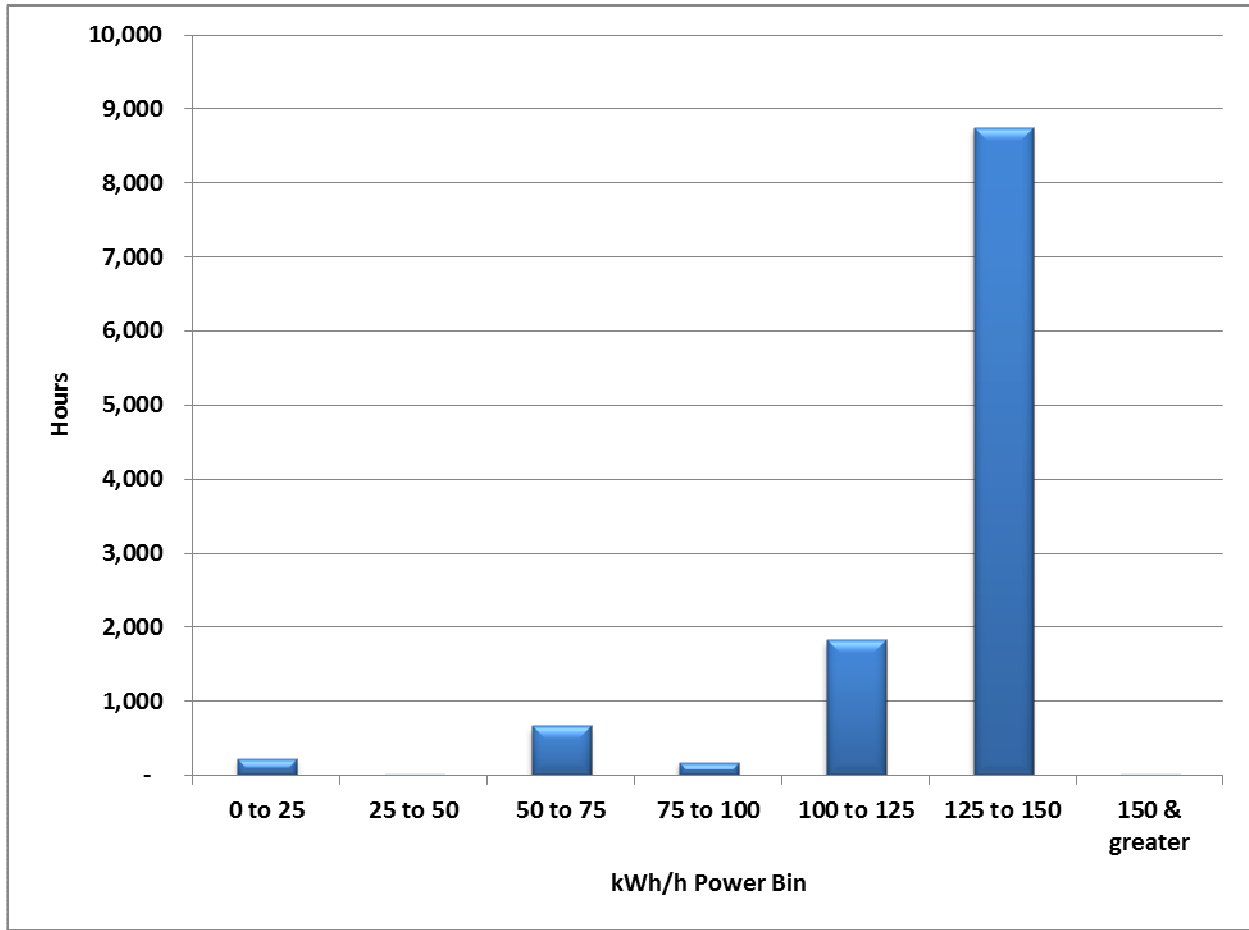
FIGURE 16 PERFORMANCE BY POWER BINS

During the 11,657 hours that met the range and relational checks 90.7% of this time, the CHP system delivered 100 kW and greater (Figure 16).

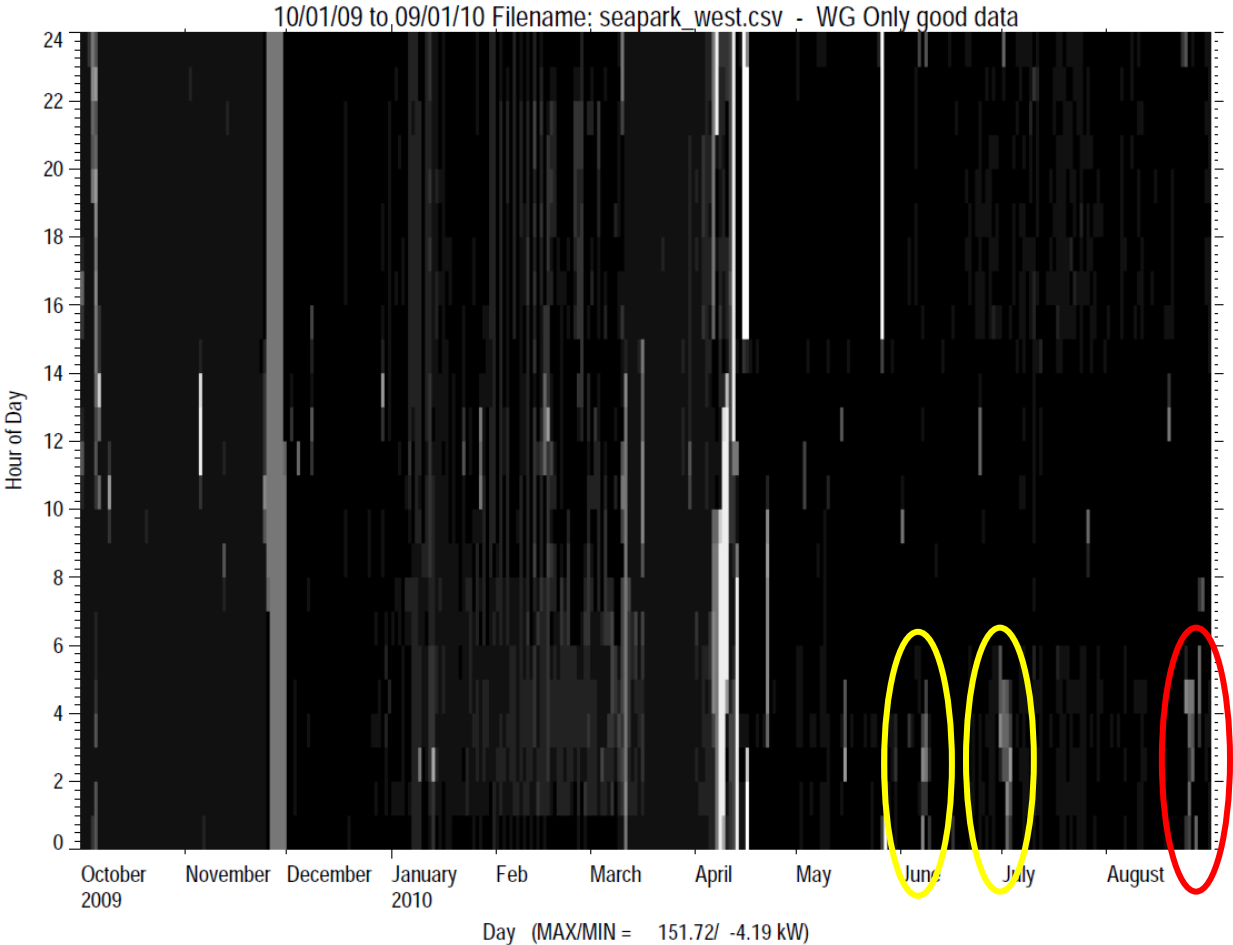
FIGURE 17 SHADE PLOT OF ONE GENERATOR PERFORMANCE

The Shade Plot in Figure 17 shows that during the last week in August 2010, this engine generator reduced performance. This electric power reduction was due to operational testing of the site’s standby generator.

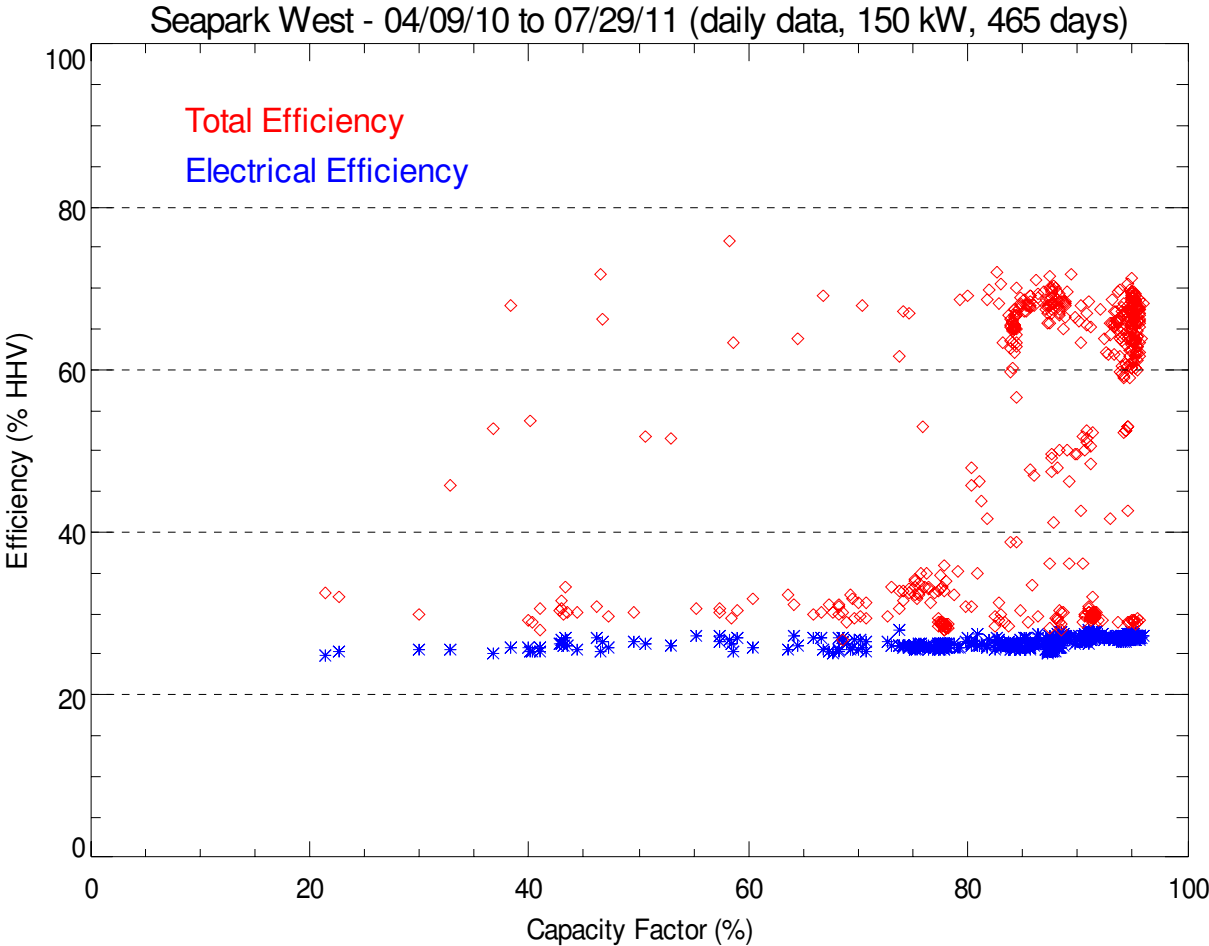
FIGURE 18 CAPACITY FACTOR⁴

Capacity Factor (FIGURE 188) presents the CHP generated power efficiency over the time period (465 days). This Figure provides a very good overview of the CHP power capacity versus site power requirements and a good understanding of the useful thermal energy recovered. The Figure shows the system generally operated between 20% and 95% of the generating capacity at about 26.8% power efficiency (HHV) during the last 12 months of Table 2. The electric capacity supports the electric load following operation pattern observed in the previous graphs. The useful thermal energy (heating and DHW) operating efficiency during the entire period averaged 22.9% thermal efficiency (HHV). The thermal profile shows high capacity generally associated with high electric capacity. Examining the useful thermal data over time shows slightly higher useful thermal energy performance in the summer than in the winter.

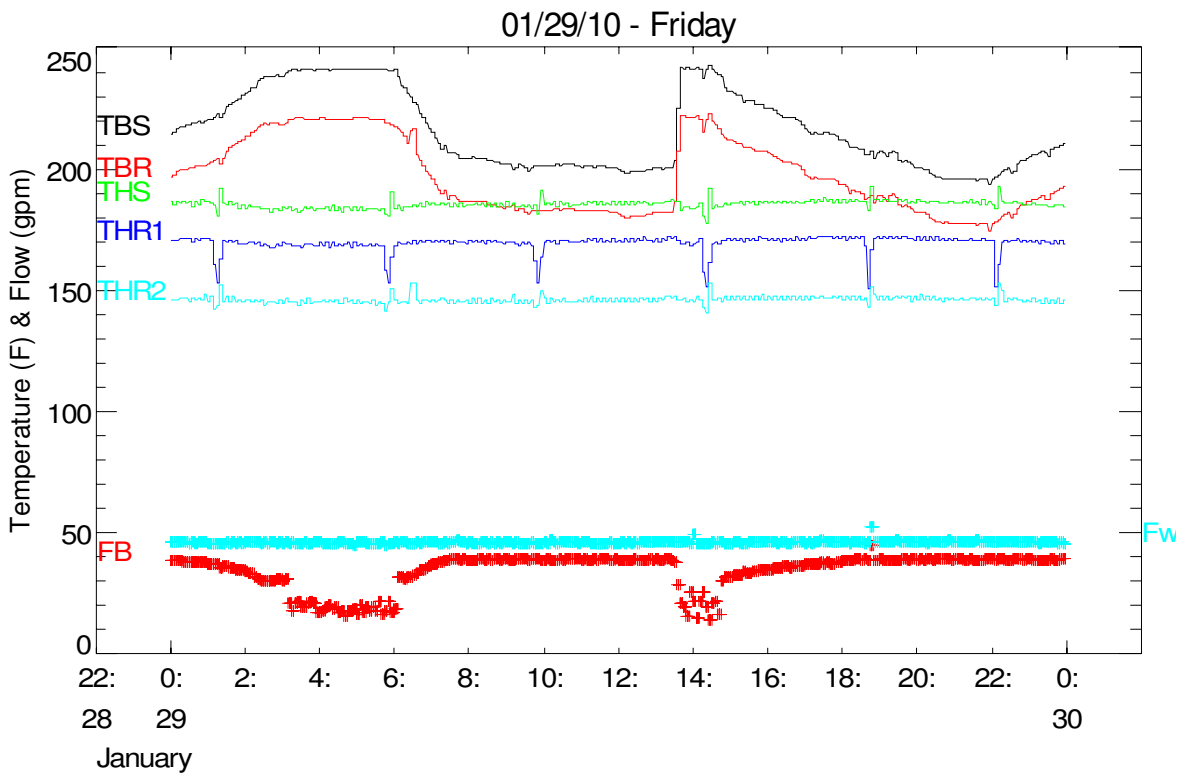
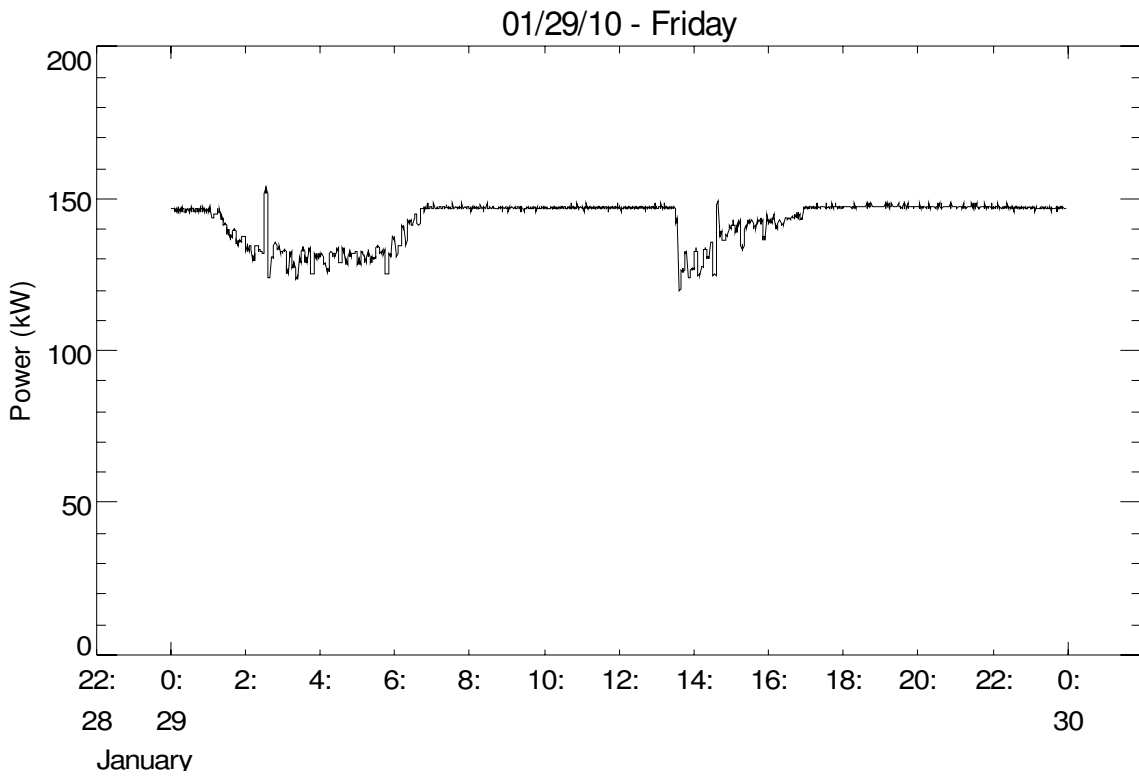
10/22/10 - Friday

The engine exhaust heat exchanger for the Tecogen 75 units adds heat into the water drum of the 10 psig boilers (Figure 2). The temperature of supply and return water to the boiler drum (TBS and TBR) is plotted on the following Figures for 4 different days. The temperature of the water in the boiler drum periodically increases from 205°F Supply (185°F Return), to 240°F Supply (220°F Return), presumably when the boiler fires. Whenever this happens, the Tecogen units appear to decrease their power output by 10-50 kW. This implies the units throttle back power output in response to a temperature (or pressure) sensor in the exhaust heat exchanger loop. The flow through the boiler (FB) decreases when the temperature goes up which implies the hot water may be flashing.

The temperature of the jacket water loop back to the engine (THR2) remains constant throughout this period. This behavior is only observed when the heat recovery piping is in the “4-pipe arrangement” with flow to the boiler. It does not occur in the “2-pipe arrangement” with the exhaust heat exchanger in series with the jacket water loop.

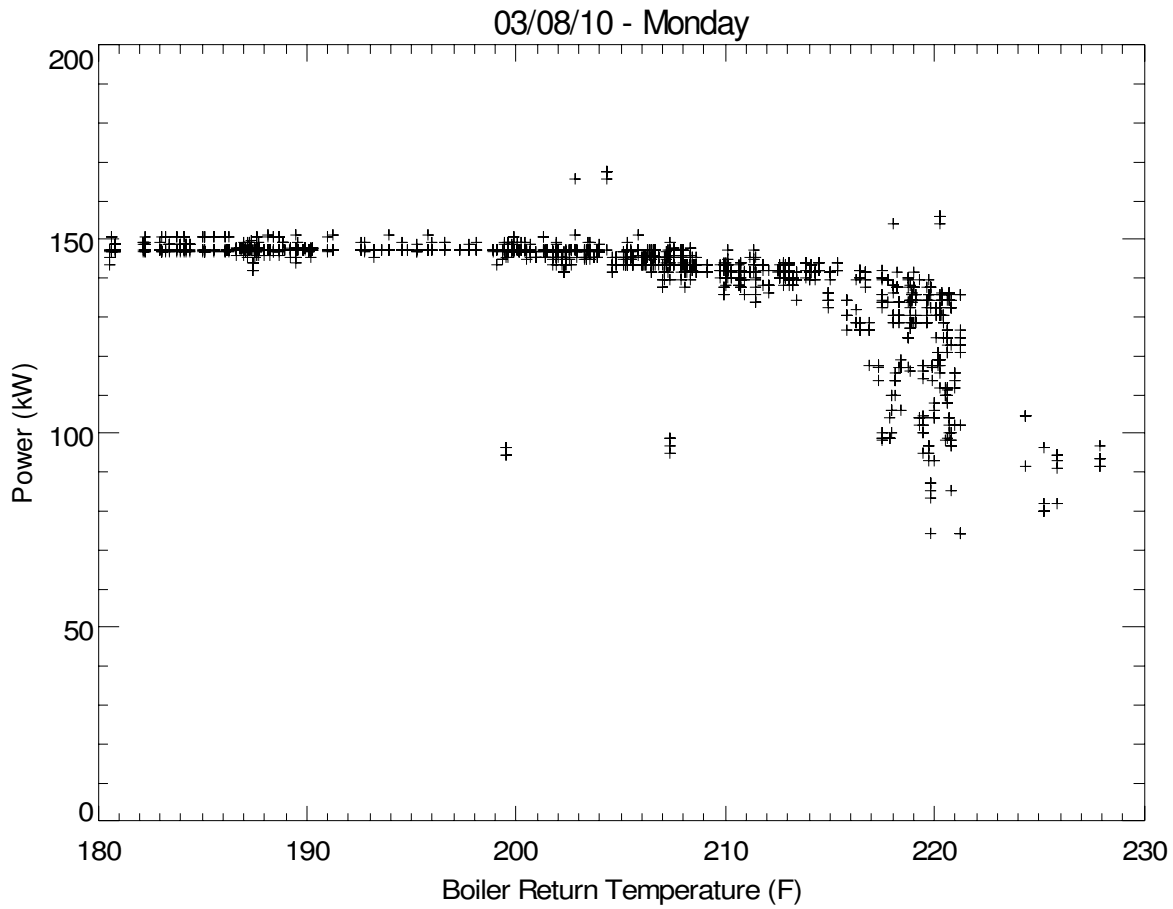
This plot implies that the sensor limiting engine power output is on the return side of the heat exchanger. It appears to limit power output at about 220°F.
